# Pedestrian Environment Street Audit Review

Bletchley and Fenny Stratford

October 2022

# PERS: 2022 Street Audit Bletchley & Fenny Stratford

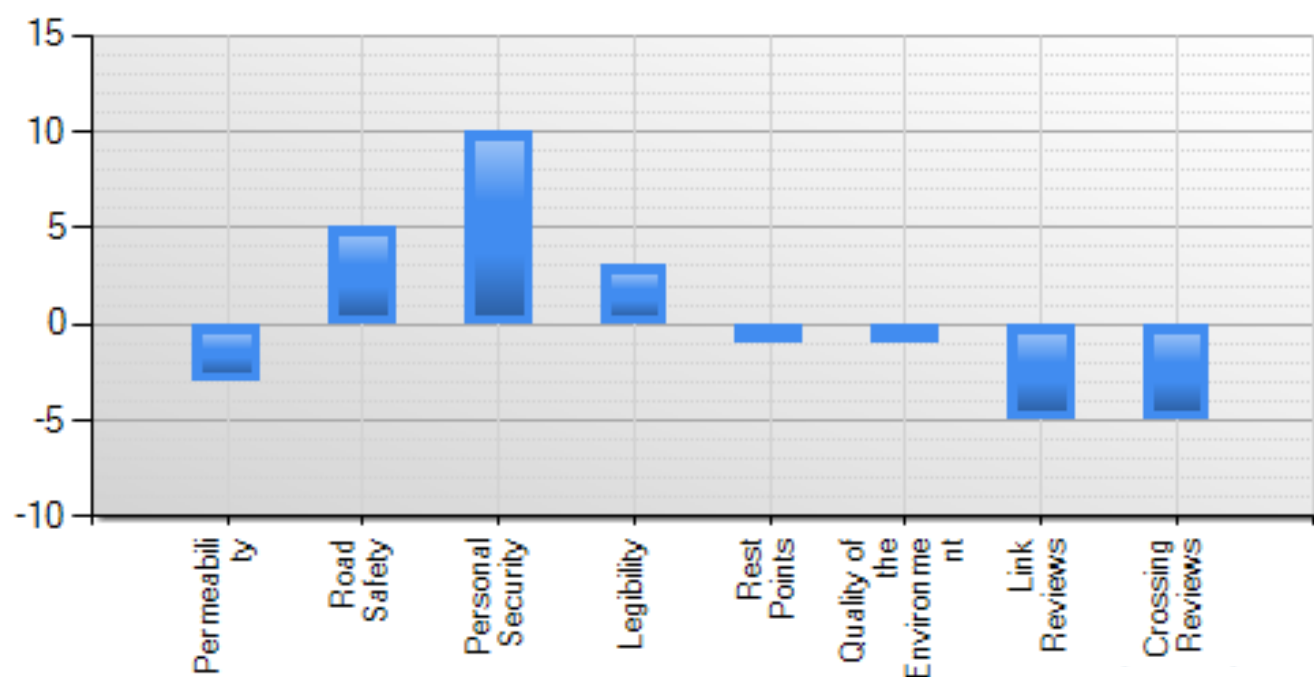
Fig 2 Route 1 image showing pedestrian environment evaluated across Stanier Square

- 3.11 Routes 1, 3 and 9 received average or above average scores. They generally follow the high streets of Bletchley and Fenny Stratford via Queensway and Aylesbury Street respectively and therefore are expected to handle the greatest levels of pedestrian footfall and activity. They are along direct routes for pedestrians and with a good level of legibility. The pedestrian environment was generally good, feeling open and active yet safe along mostly single carriageway roads. However, the route varies in footpath surface quality across its entirety, reducing dramatically east of Elizabeth square. Personal security for pedestrians scored relatively well as there was adequate lighting and wide footways adjacent to the road and they are generally well overlooked.

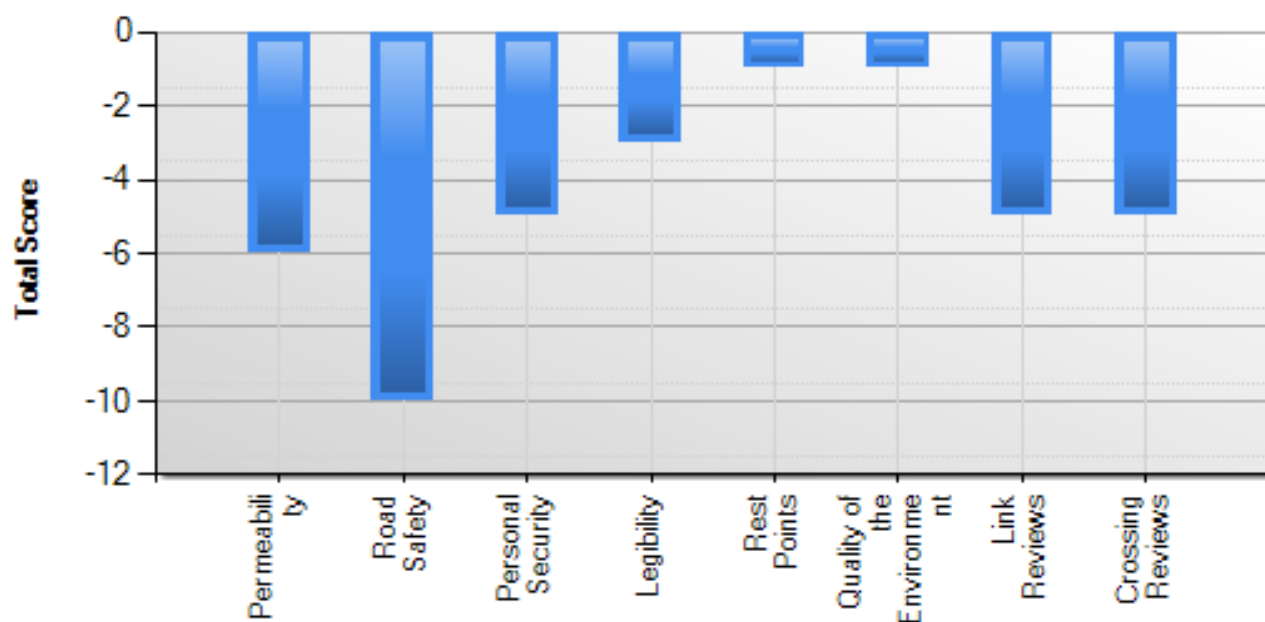
Fig 19 Route 2 image showing pedestrian environment evaluated beneath Stephenson House.

- 3.5 Route 2 connecting Bletchley Bus Station to Bletchley Library, Route 5 connecting the concourse at Brunnell shopping centre to Dukes Street Retail park via Locke Road and Albert Street, and Route 7 connecting Bletchley Bus Station to Bletchley Leisure Centre via Princess Way where amongst the poorest scoring routes. These routes scored poorly, and most severely, in terms of environmental quality, personal security and road safety criteria.

- 3.6 Routes 5 and 2 also scored particularly poorly on personal security as some sections of these routes felt rather closed in and poorly overlooked by surrounding development. Pedestrian lighting infrastructure improvements could be made to help night hour use. Safety is an issue here as some connections are somewhat inaccessible or hazardous to pedestrians. These are also routes where wheelchair access remains severely restricted. This is not just apparent by the severely reduced footway widths and lack of ramps but also by the lack of dropped kerbs, correct blister paving for the sensory impaired and lack of smooth surfaces on the approaches to and from the bus station. Pedestrian barriers and parked cars on footways drives the score lower still, so an increased level of enforcement action might provide some immediate improvements. There is also, however, an opportunity for some 'quick win' uplifts in scores with the introduction of improved crossing provisions, surfaces, signage, introduction or repair of existing benches for rest points and an uplift in lighting provision along some lengths of the routes identified.

- 3.10 Part of Route 2 is a 'pedestrian only' area which also runs through public spaces 1 and 2 (evaluated separately) and between the Brunel Centre and under Stephenson House. Improvements to the public realm in these areas should be considered as a high priority along side any future development proposals for the surrounding buildings and wider town centre.

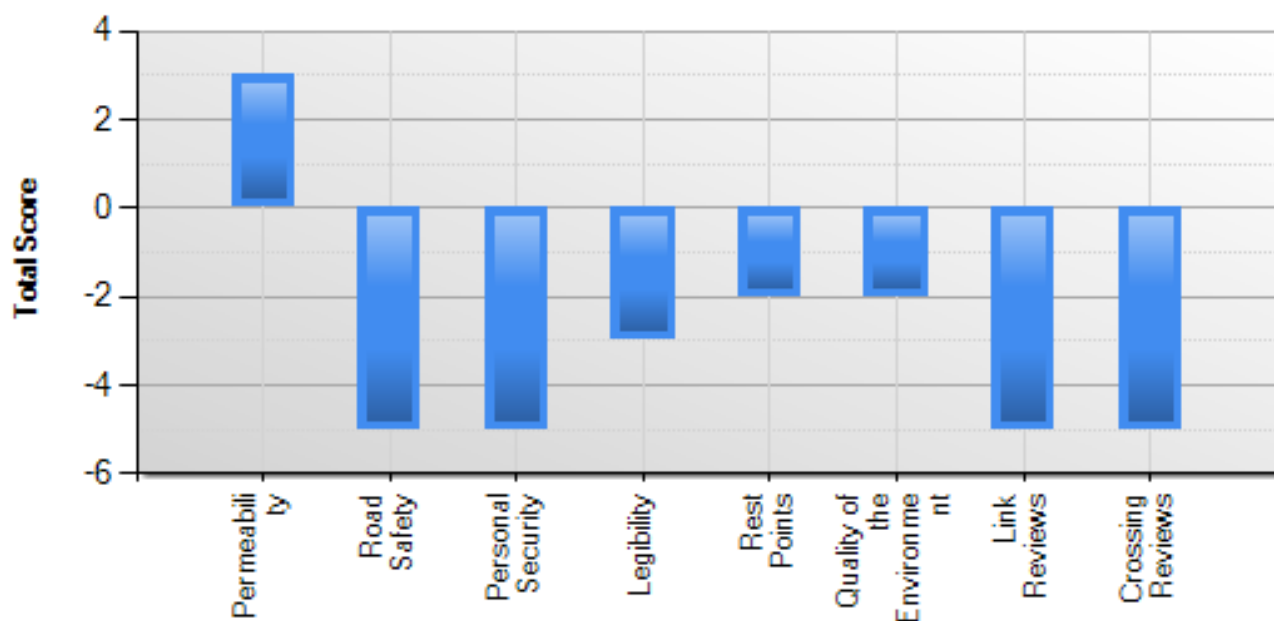
Fig 39 Route 4 image showing pedestrian environment evaluated along Albert Street at entrance to car parks.

3.8 Route 4 also scored poorly, although not currently a route considered as particularly popular or attractive to pedestrians. This route does, however, provide the shortest way that connects the Library and Town Centre to the Bus Station via Albert Street, Cawkwell Way and Westfield Road. The directness of this route was still considered quite poor with little signage to aid way finding. There was also an issue with a lack of pedestrian footway provision on both Cawkwell Way and Findlay Way. Presumably historically removed, a rather short sighted decision, in preference of a greater number of parking spaces within the streets scene.

3.9 Albert Street generally felt cluttered and unsafe for pedestrians on both sides of the street due mainly to multiple access points to the adjacent surface level car parks. Paths arbitrarily narrow, widen and terminate with no defined onward route apparent to pedestrians other than an option to join the road to cross the car parks.
